**CHARLES RIVER BASIN  
MILFORD, MASSACHUSETTS**

**CEDAR SWAMP POND DAM  
MA 00628**

# **PHASE I INSPECTION REPORT NATIONAL DAM INSPECTION PROGRAM**

**JULY 1978**

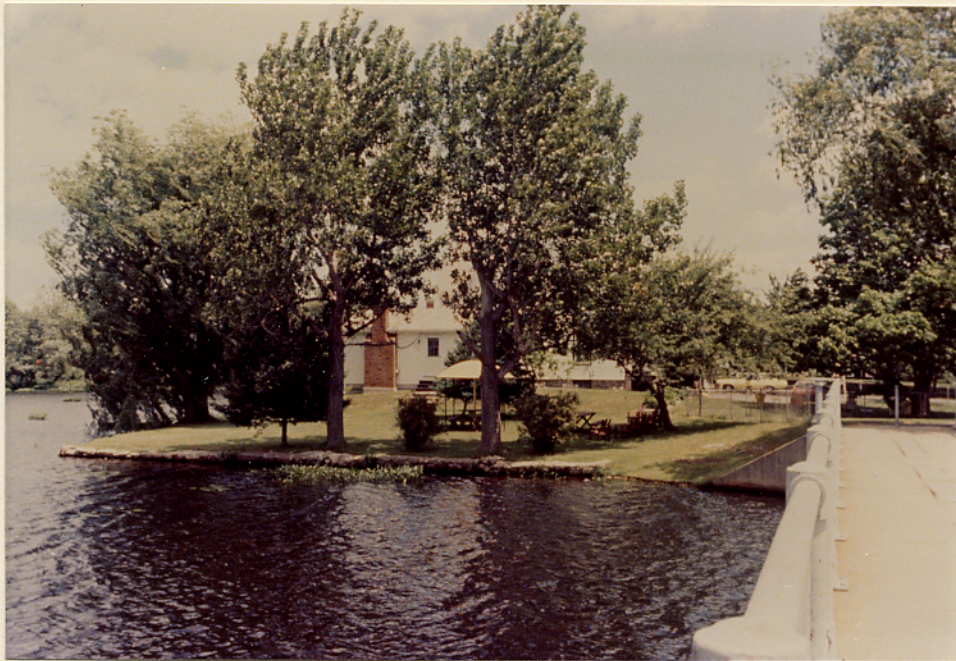
**NO. 1 - VIEW OF EAST ABUTMENT, UPSTREAM AREA**

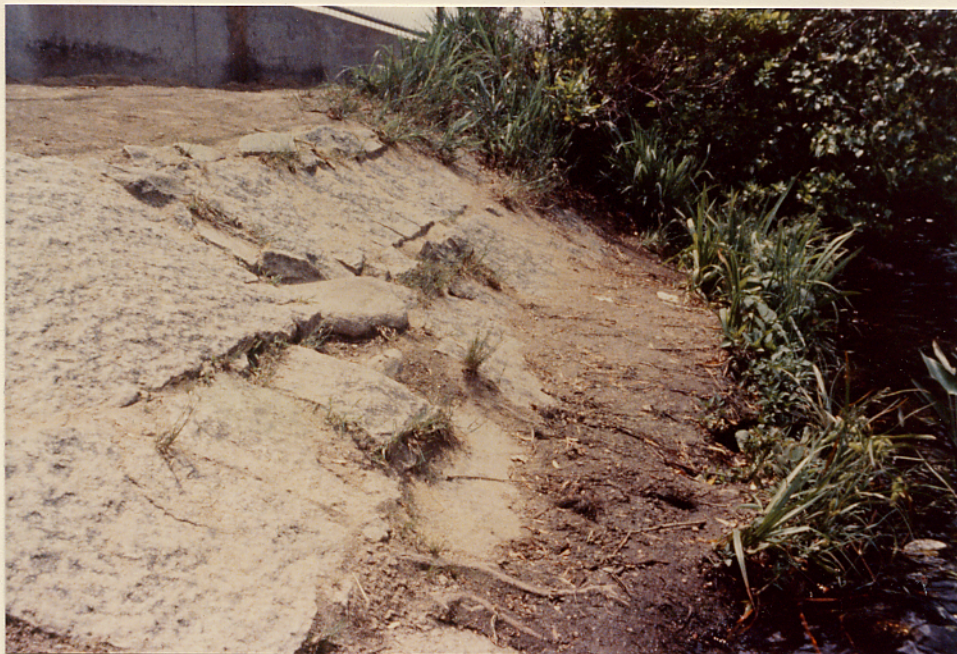
AREA EVALUATED	CONDITIONS
<u>DAM EMBANKMENT</u>	
Crest Elevation	varies from 272.5 to 274.6
Current Pool Elevation	269.2
Maximum Impoundment to Date	unknown
Surface Cracks	none visible
Pavement Condition	asphalt walkway pavement poor on west abutment; good on east abutment
Movement or Settlement of Crest	none visible
Lateral Movement	none visible
Vertical Alignment	relatively straight
Horizontal Alignment	relatively straight
Condition at Abutment and at Concrete Structures	minor erosion of soil beneath pavement at each abutment, downstream face
Indications of Movement of Structural Items on Slopes	none
Trespassing on Slopes	footpaths along upstream crest (west abutment) + along downstream sidewalls
Sloughing or Erosion of Slopes or Abutments	erosion of upstream slope 65' west of concrete deck; 3ft dia. willow tree on each abutment - roots to sidewalls
Rock Slope Protection - Riprap Failures	unchinked riprap on upstream face - some grass + brush growth

**NO. 2 - DETAIL OF RIP RAP ON UPSTREAM FACE OF WEST ABUTMENT**

- (3) clear shrubs, brush, and grass from upstream face of dam embankment and clear weed growth from sides and bottom of downstream channel;
- (4) repair and resurface spalled and eroded portions of concrete in the spillway and sluice gate structures;

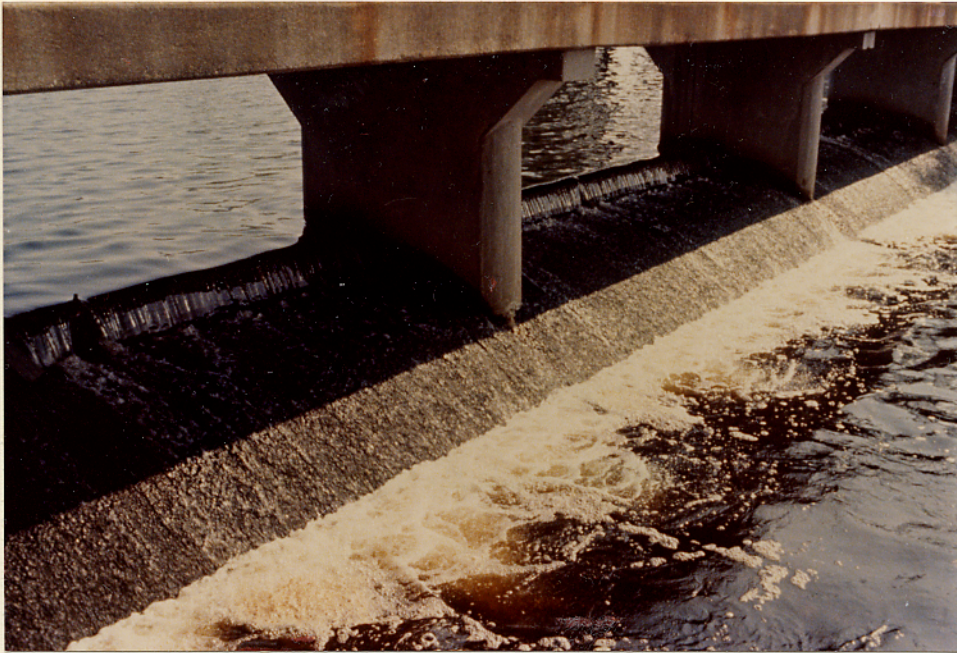
- c. Visual Observations. The concrete ogee spillway for Cedar Swamp Pond is ungated and flow is unrestricted. Eleven (11) inch removable flashboards are in place along the dam crest. However, the access plates to the flashboards are welded shut and the flashboards cannot easily be removed. Also the eye bolts for the flashboards are missing. The general condition of the spillway is good except for some minor concrete spalling.

\* flashboards in place on top of spillway crest - 10" high, wooden - missing eye bolt for removal - plates for access on deck surface are welded shut.

**NO. 3 - DETAIL OF SPILLWAY WEIR SHOWING  
FLASHBOARDS AND CONCRETE PIERS**

- (5) reopen access plates to flashboards and shut using bolts only;
- (6) install eyebolts on flashboards;
- (7) implement a systematic program of inspection and maintenance. As a minimum, the inspection program should consist of a monthly inspection of the dam and appurtenances and should be supplemented by additional inspections during and after severe storms. Operation of the slide gates should also be checked at least twice a year. All repairs and maintenance should be undertaken in accordance with all applicable State regulations.

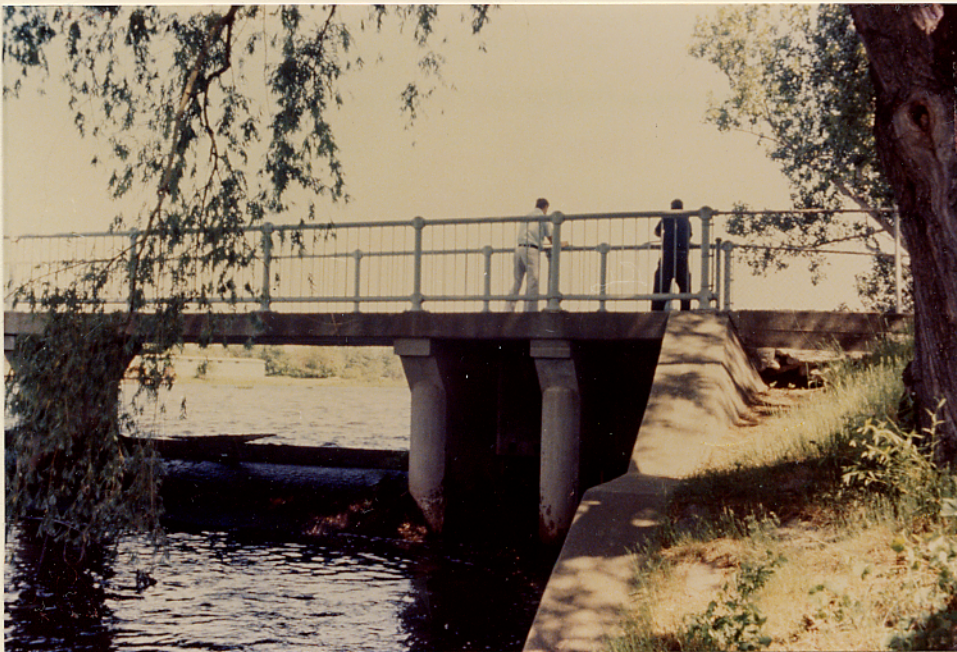
**NO. 4 - VIEW OF EAST ABUTMENT, DOWNSTREAM  
FACE, WITH SLIDE GATES IN CENTER OF PICTURE**

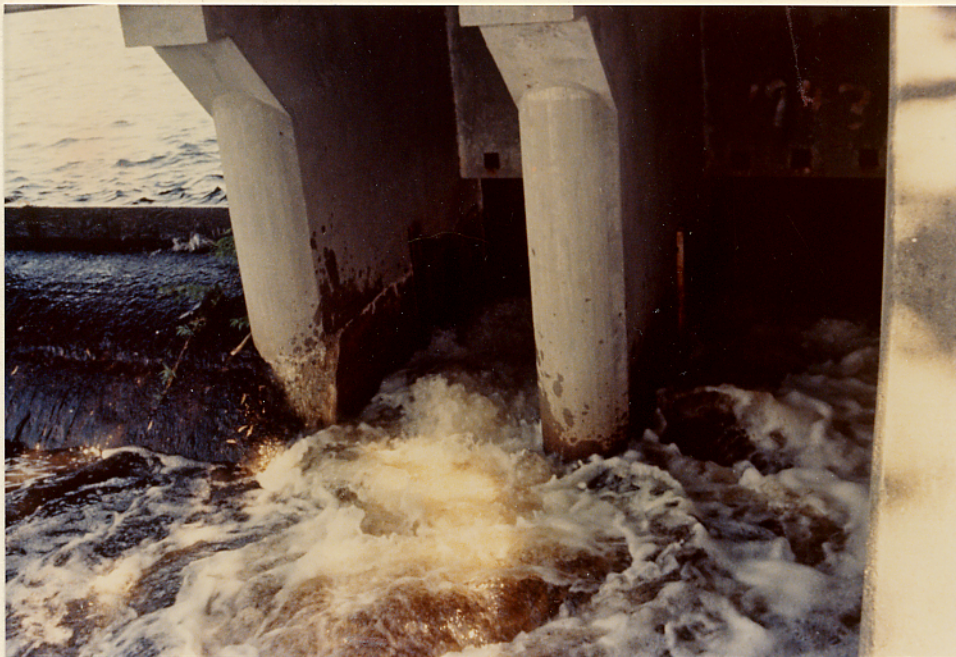
two 4-foot slide gates operated by hand wheels - good condition - made of steel

**NO. 5 - VIEW OF SLIDE GATES OPEN**

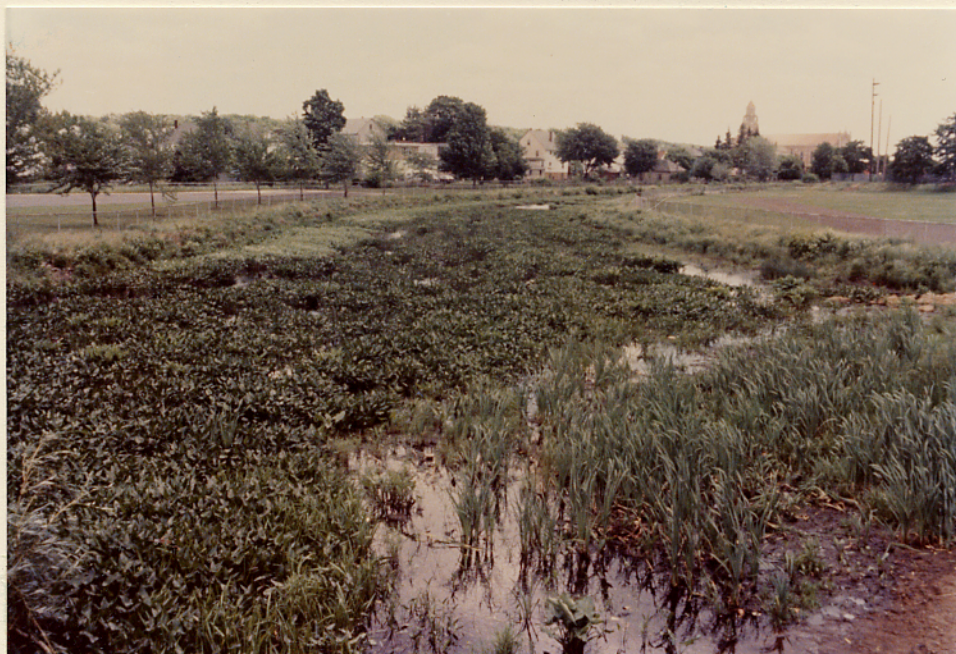
AREA EVALUATED	CONDITION
* <u>OUTLET WORKS - OUTLET STRUCTURE AND OUTLET CHANNEL</u>	
General Condition of Concrete	<u>good</u>
Rust or Staining (discoloration)	<u>slight stain at water level</u>
Spalling	<u>slight around downstream face of pier at water line</u>
Erosion or Cavitation	<u>slight erosion on downstream face of pier next to spillway weir</u>
Visible Reinforcing	<u>none</u>
Any Seepage or Efflorescence	<u>slight seepage from joint on east face of pier next to weir</u>
Condition at Joints	<u>fair to good</u>
Drain Holes	<u>none visible</u>
Channel	
Loose Rock or Trees Overhanging Channel	<u>3' diameter willow tree on each side of channel at abutment</u>
Condition of Discharge Channel	<u>channel bottom choked with weeds + trash - rip rap in place</u>
	<u>channel sides overgrown with grass - rip rap in place</u>

**NO. 6 - OVERVIEW OF DOWNSTREAM CHANNEL  
LOOKING FROM CENTER OF DAM**
